# FELDI'S BUILDING INSPECTIONS

SERVING SOUTH FLORIDA SINCE 1989  
INSPECTION REPORT

123 SAMPLE REPORT  
CONDO #207  
BOCA RATON FL

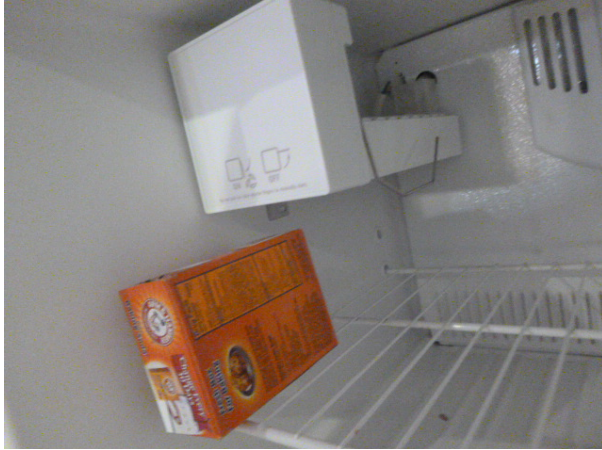
1. THE ICE MAKER COULD NOT BE TESTED AS IT IS NOT CONNECTED TO A WATER LINE. ALSO, THE ICE MAKER BEEN IS MISSING. APPROXIMATE HOOKUP COST. \$100 – \$150 APPROXIMATE BEEN REPLACEMENT COST. \$35 – \$45 APPROXIMATELY ICE MAKER REPAIR COST IF NECESSARY. \$150 – \$450

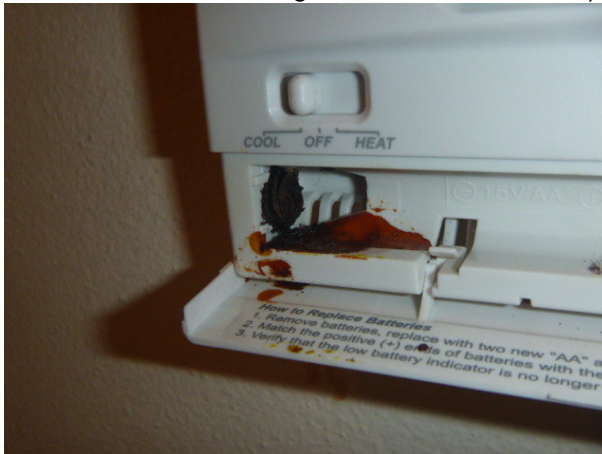
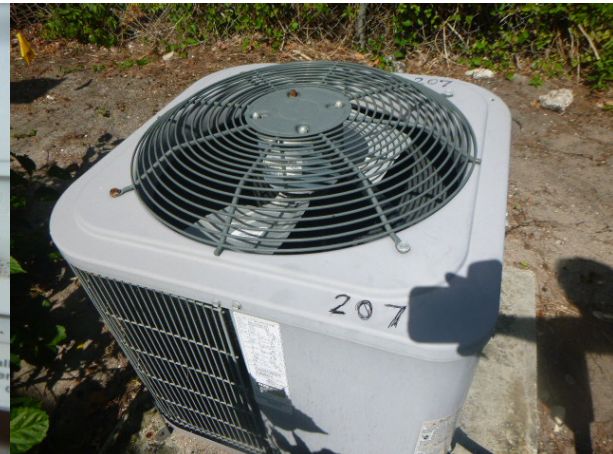
**AIR-CONDITIONING:** NOT COOLING PROPERLY, SERVICING NECESSARY

THE AIR-CONDITIONING HAD ONLY A 10 DEGREE TEMPERATURE DIFFERENTIAL. A 80 DEGREE READING WAS TAKEN AT THE RETURN AIR GRILL AND A 70 DEGREE READING AT THE DIFFUSER. THE REPAIRING CONTRACTOR SHOULD CHECK FOR A POSSIBLE REFRIGERANT LEAK. ALSO, THE THERMOSTAT ITSELF IS DEFECTIVE DUE TO A LEAKING BATTERY AND NEEDS TO BE REPLACED. APPROXIMATE ANTICIPATED REPAIR COST. \$700 – \$2200 (note, the air conditioning system was manufactured in 2017 the normal maximum life air conditioning system, is 13 to 15 years. The photo below right is the exterior condensing unit located in the rear.)

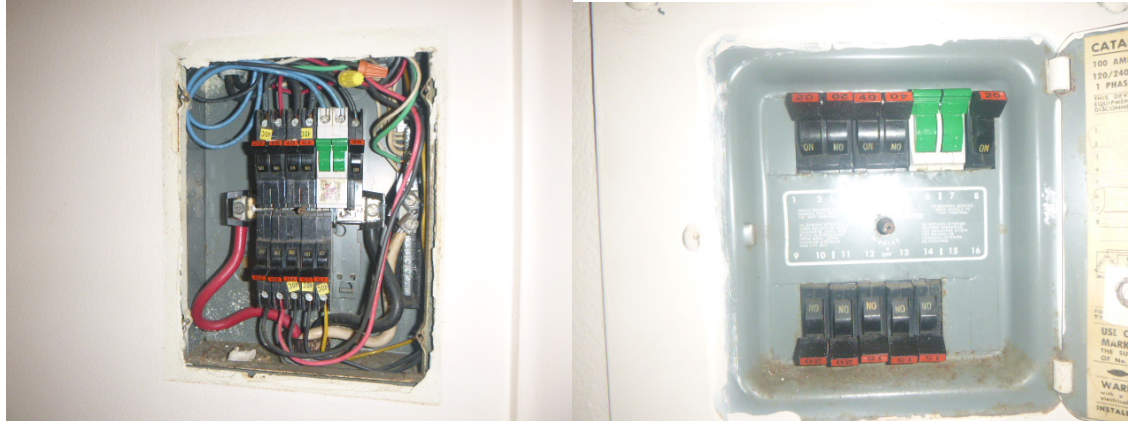
1. THE INTERIOR ELECTRICAL PANEL WAS MANUFACTURED BY FEDERAL PACIFIC. THIS PARTICULAR BRAND PANEL IS DEEMED EFFICIENT AND UNSAFE, REPLACEMENT IS NECESSARY. APPROXIMATE REPLACEMENT COST. \$1200 – \$1600

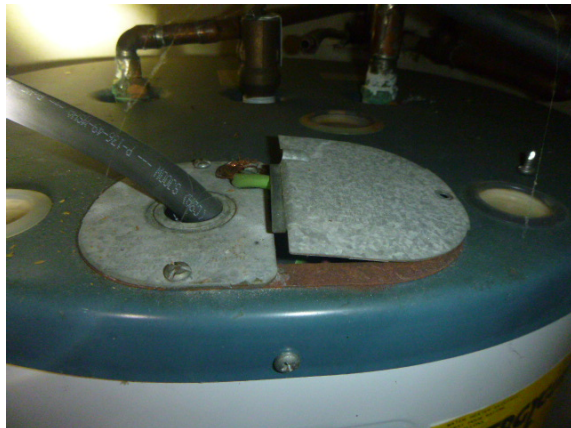
2. WATER HEATER CORD IS NOT CLAMPED WHERE IT ENTERS THE WATER HEATER, IN ADDITION THE COVER IS NOT PROPERLY SECURED. APPROXIMATE REPAIR COST. \$45 – \$65

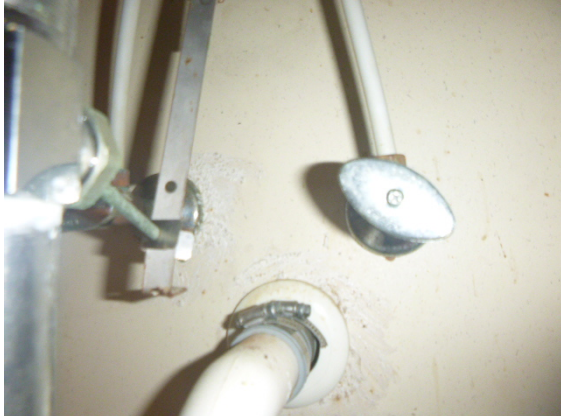
2. THE VARIOUS SHUT OFF VALVES UNDER THE SINKS AND THE TOILET ARE SEIZED UP AND NOT WORKING. APPROXIMATE REPAIR COST. \$45 – \$125 EACH

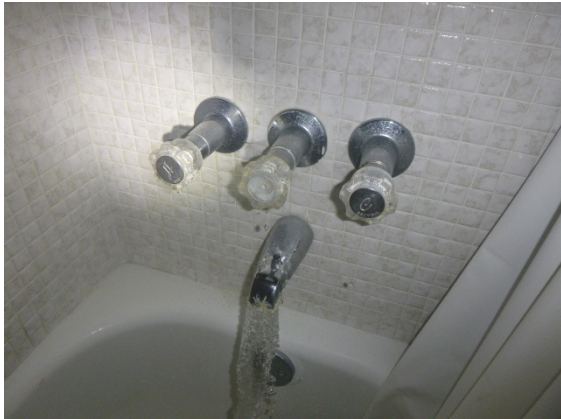
3. ALL THREE BATHTUB VALVES LEAK WHEN ON. APPROXIMATE REPAIR COST. \$45 – \$95 EACH

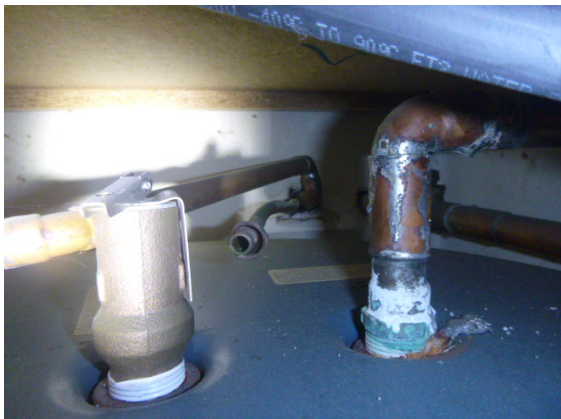
5. THE WATER HEATER HIGH PRESSURE RELIEF VALVE IS NOT CONNECTED TO THE EXTERIOR LINE. APPROXIMATE REPAIR COST. \$75 – \$125

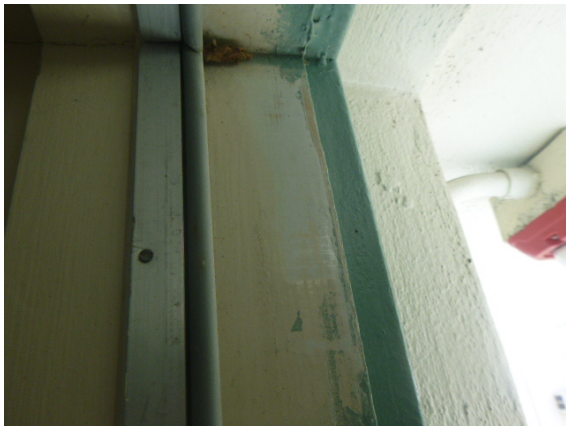
1. LIVING ROOM, ALL THREE WINDOWS NEED SERVICING, ALL APPEAR TO HAVE BROKEN SPRINGS OR A DAMAGED LOCK. ALSO, THE WINDOW GUIDES ARE MISSING. APPROXIMATE SERVICING COST. \$45 – \$95 EACH WINDOW
2. MAIN FRONT ENTRY DOOR STICKS AT THE TOP. APPROXIMATE REPAIR COST. \$45 – \$65

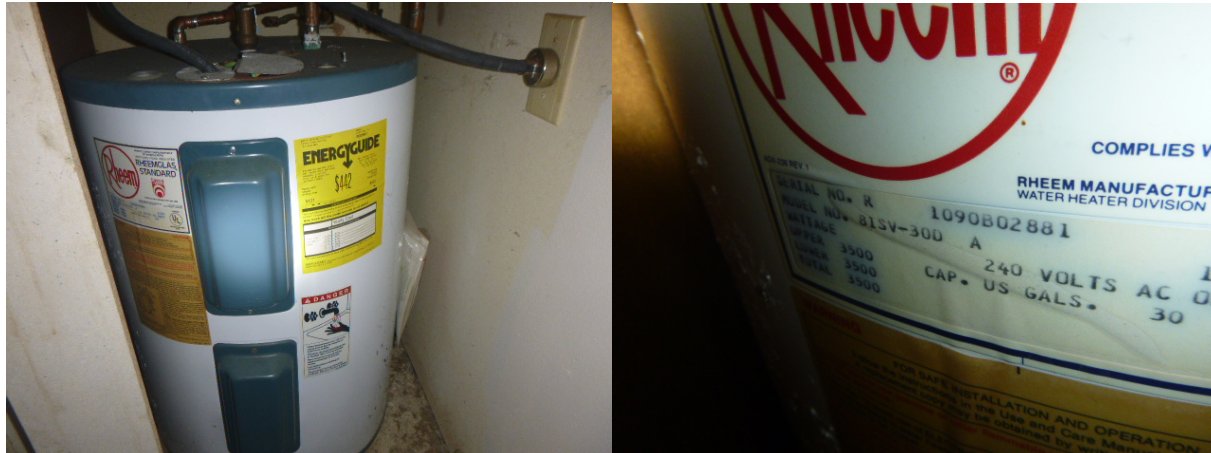
**HOT WATER HEATER:** ELECTRIC DOUBLE ELEMENT TYPE: WORKING (note, the water heater was manufactured in 1990 and has a 30-gallon capacity. The normal maximum life water heater, is 13 to 15 years. As this water heater has exceeded its design life, replacement may soon be necessary. Approximate replacement cost. \$1200 – \$1400.)
