FELDI'S BUILDING INSPECTIONS

INSPECTION REPORT

7654 SAMPLE
HOUSE
BOYONTON BEACH FL

INSPECTION DATE: 4-27 -2021

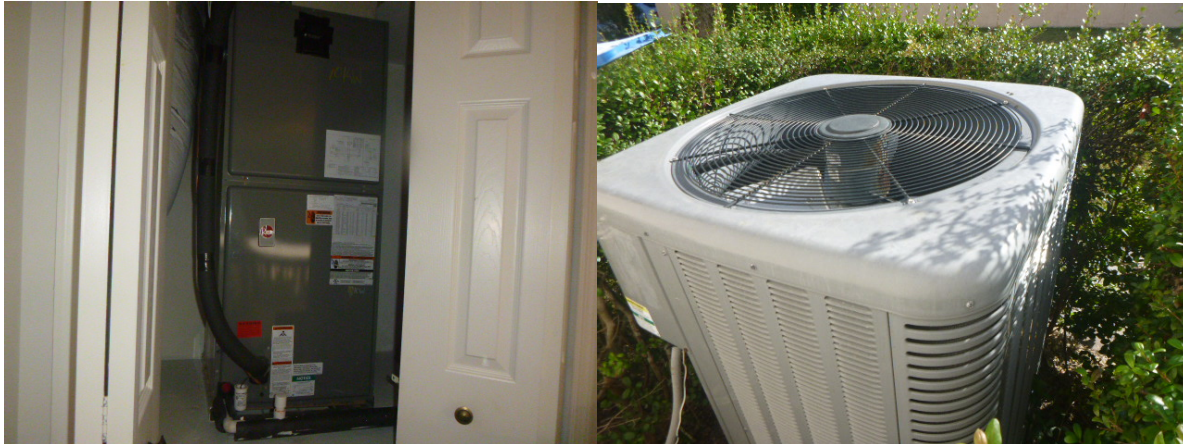
THE AIR-CONDITIONING WAS WORKING AT THE LOWER END OF THE ACCEPTABLE RANGE WITH A 14 DEGREE TEMPERATURE DIFFERENTIAL. A 72 DEGREE READING WAS TAKEN AT THE RETURN AIR GRILL AND A 58 DEGREE READING AT THE DIFFUSER. SERVICING OF THE SYSTEM IS RECOMMENDED PRIOR TO SUMMER. ALSO, THE AIR CONDITIONING CONTRACTOR SHOULD CHECK FOR A POSSIBLE REFRIGERANT LEAK. (note, the air conditioning system was manufactured in 2015 the normal maximum life air conditioning system, is 13 to 15 years. The photo below left is the inside air handler, located in the second-floor bedroom closet. The photo below right is the exterior condensing unit. Also, several of the air-conditioning diffusers are dirty and need cleaning.)

On air-conditioning systems over five years old, it is common for coils to need cleaning in the air handler. Also, there is a possibility of concealed mold evidence inside the air handler cabinet, due to the age of this unit. Our air conditioning inspection is noninvasive, consequently we do not open up the air conditioning unit and inspect the insides. **A licensed air-conditioning contractor should be acquired prior to purchase of the property.** for an internal assessment of the condition of the air handler. As well as inspecting for concealed mold inside the air handler and adjacent ductwork.

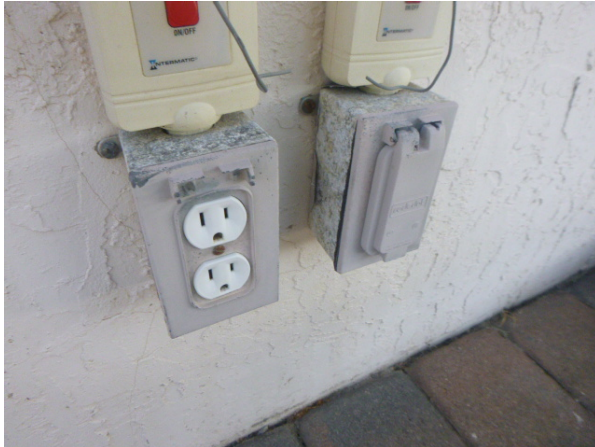
2. REAR PORCH, THE SOUTH OUTLET HAS A COVER DOOR THAT IS MISSING. ALSO, THE ADJACENT OUTLET HAS NO POWER. MOST LIKELY THIS IS DUE TO A REMOTE-CONTROL UNIT THAT IS ATTACHED. THIS COULD NOT BE TESTED AS A REMOTE CONTROL WAS NOT AVAILABLE. APPROXIMATE ANTICIPATED REPAIR COST. \$45 – \$75

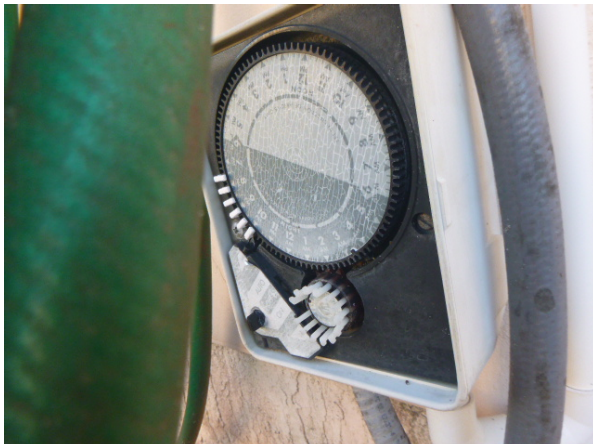
5. LAWN SPRINKLER TIME CLOCK COVER DOOR IS MISSING. APPROXIMATE REPLACEMENT COST. \$45 – \$65

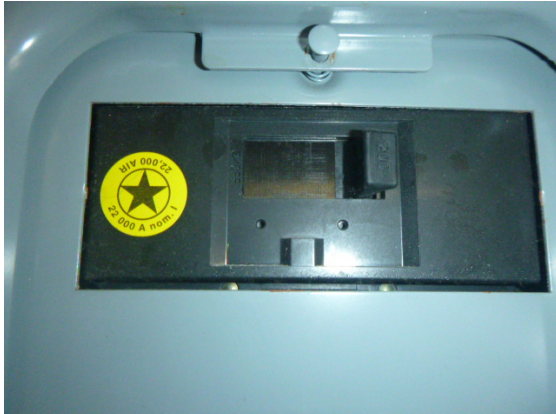
SERVICE AMPERAGE SIZE: 200 amps— the main electrical disconnect is located inside the garage electrical panel at the top, see photo below.

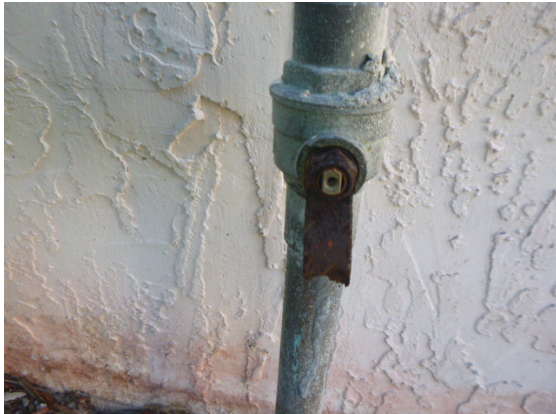
1. THE WATER MAIN SHUT OFF IN THE FRONT OF THE HOUSE COULD NOT BE TESTED AS THE HANDLE HAS RUSTED OFF. APPROXIMATE HANDLE REPLACEMENT COST. \$10 – \$20 APPROXIMATE SHUT OFF VALVE REPLACEMENT COST IF NECESSARY. \$300 – \$450

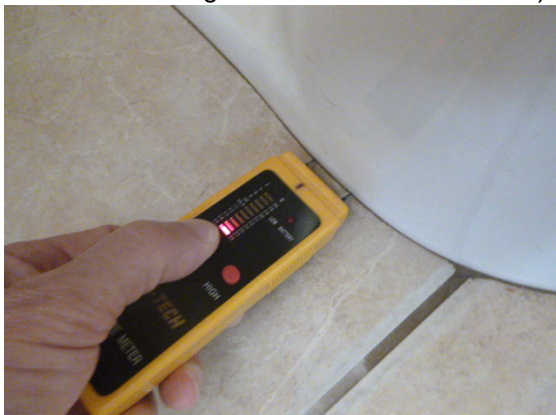
2. MASTER BATHROOM TOILET IS LEAKING AT THE BASE; A NEW WAX RING NEEDS TO BE INSTALLED UNDER THE TOILET. APPROXIMATE REPAIR COST. \$175 – \$225 (the photo below shows the bottom area of the toilet checking wet with a moisture meter.)

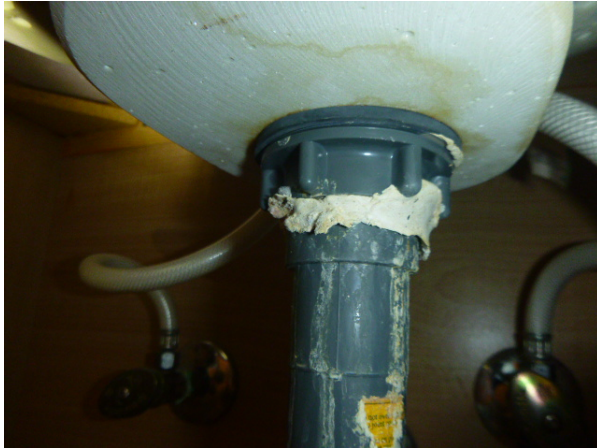
3. MASTER BATHROOM LEFT SINK HAS AN IMPROPERLY REPAIRED DRAIN. APPROXIMATE REPAIR COST. \$75 – \$125

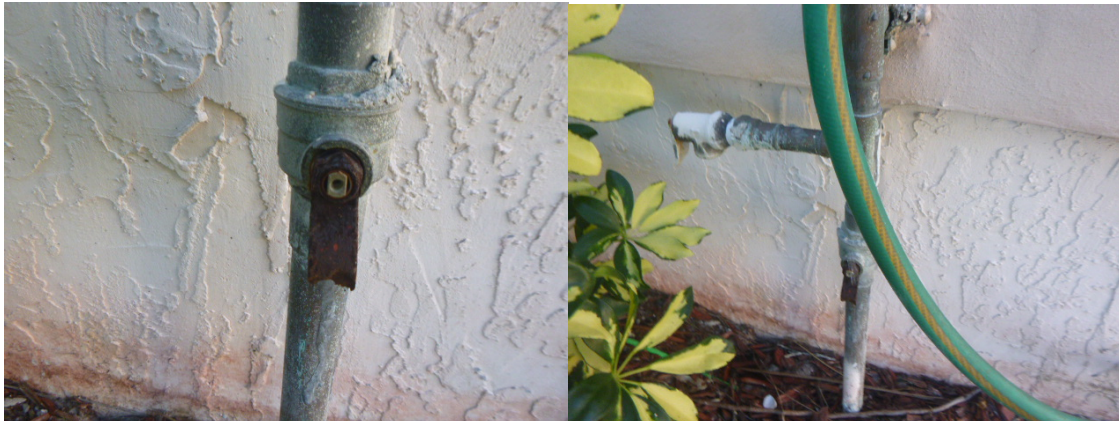
WATER MAIN SHUT OFF LOCATION: FRONT EXTERIOR, SEE PHOTO BELOWS

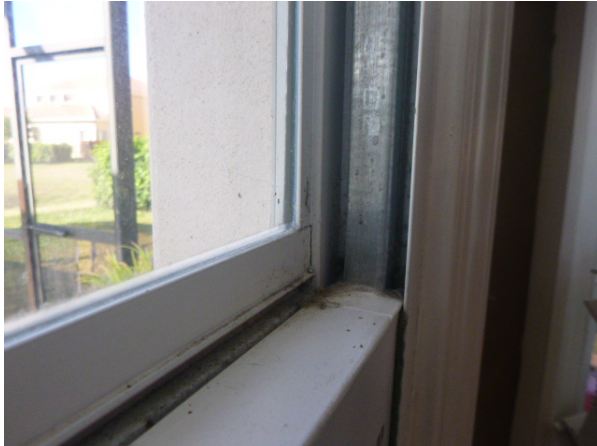
1. KITCHEN, THE CENTER BAY WINDOW HAS A BROKEN WINDOW SPRING. APPROXIMATE REPAIR COST. \$45 – \$95

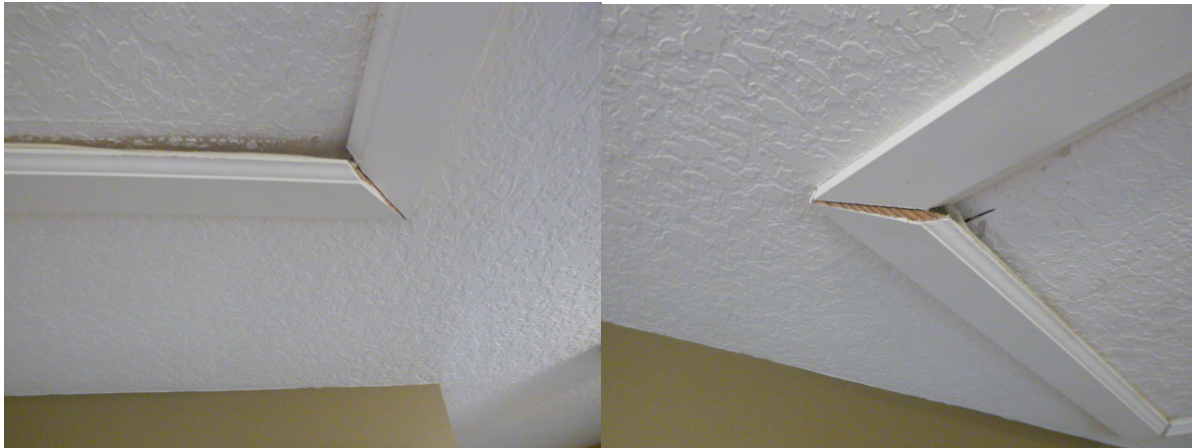
4. ATTIC LID/DOOR HAS LOOSE TRIM AROUND THE PERIMETER. APPROXIMATE REPAIR COST. \$35 – \$55

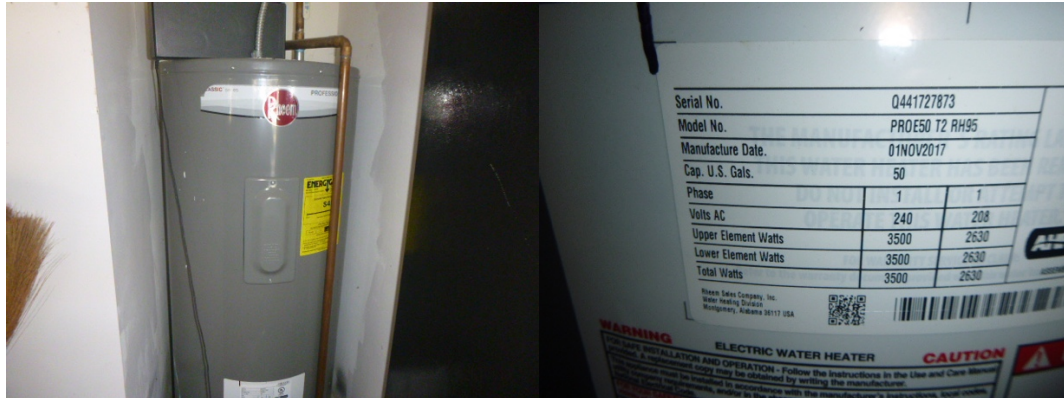
HOT WATER HEATER: ELECTRIC DOUBLE ELEMENT TYPE: WORKING (note, the water heater was manufactured in 2017 and has a 50-gallon capacity. The normal maximum life water heater, is 13 to 15 years. The photo below is the water heater, located in the garage.)

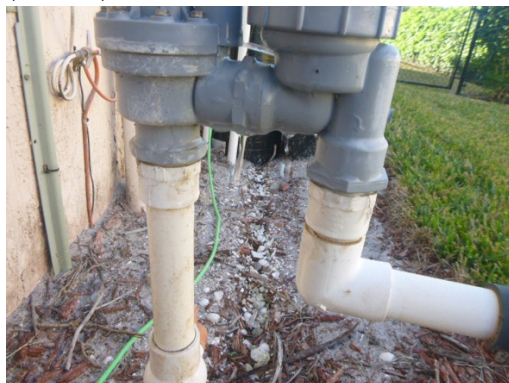
1. SEVERAL SPRINKLER HEADS PER ZONE, ARE EITHER PARTIALLY CLOGGED, MISDIRECTED OR NOT WORKING PROPERLY. APPROXIMATE REPAIR COST. \$45 – \$65 PER ZONE
2. THE SOLENOID VALVE IS LEAKING SUBSTANTIALLY WHEN ON. APPROXIMATE REPLACEMENT COST. \$150 – \$300

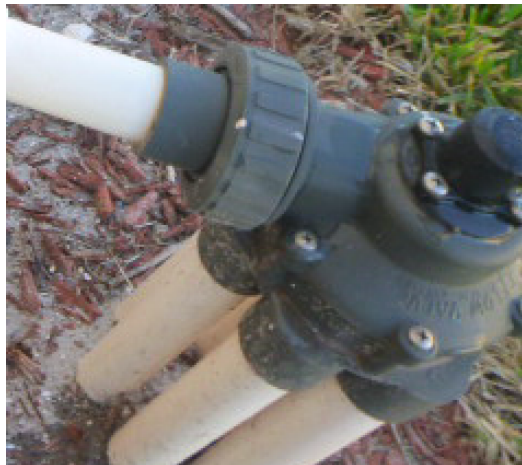
3. THE INDEXING VALVE IS STICKING, CONSEQUENTLY IT IS NOT CHANGING ZONES PROPERLY. APPROXIMATE REPAIR COST. \$150 – \$300

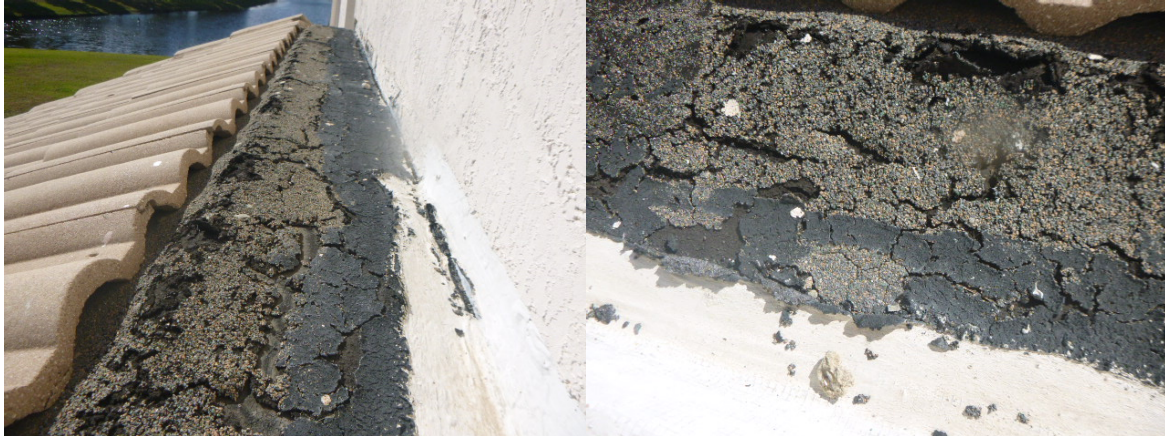
1. THE SMALL AREA DIRECTLY OUTSIDE OF THE NORTH SECOND FLOOR BEDROOMS HAS DETERIORATED ROOF MEMBRANE EXPOSED. IT IS RECOMMENDED THIS AREA BE COVERED WITH SEVERAL COATS OF "GACO 100% SILICON ROOF COATING". APPROXIMATE REPAIR COST. \$300 – \$450

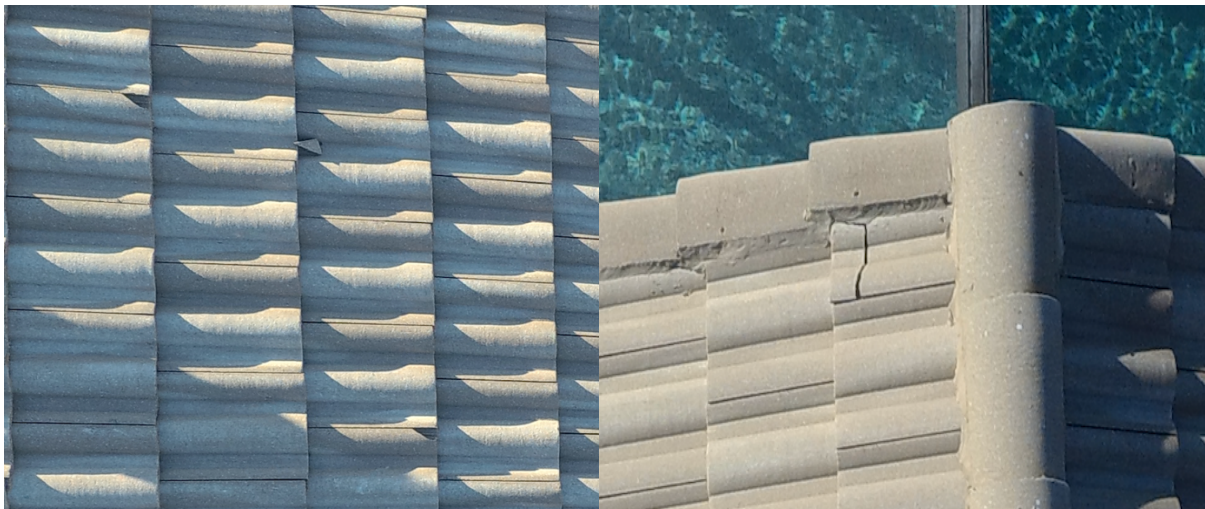
2. THERE IS APPROXIMATELY THREE DOZEN SMALL CRACKED CORNERS OF ROOF TILES. THERE IS ONE TILE AT THE SOUTH END THAT IS CRACKED FULLY THROUGH. ALL DAMAGED TILES SHOULD BE REPAIRED WITH THE APPROPRIATE ROOF ADHESIVE, SUCH AS RT 600 OR POLY FOAM. APPROXIMATE REPAIR COST. \$200 – \$400

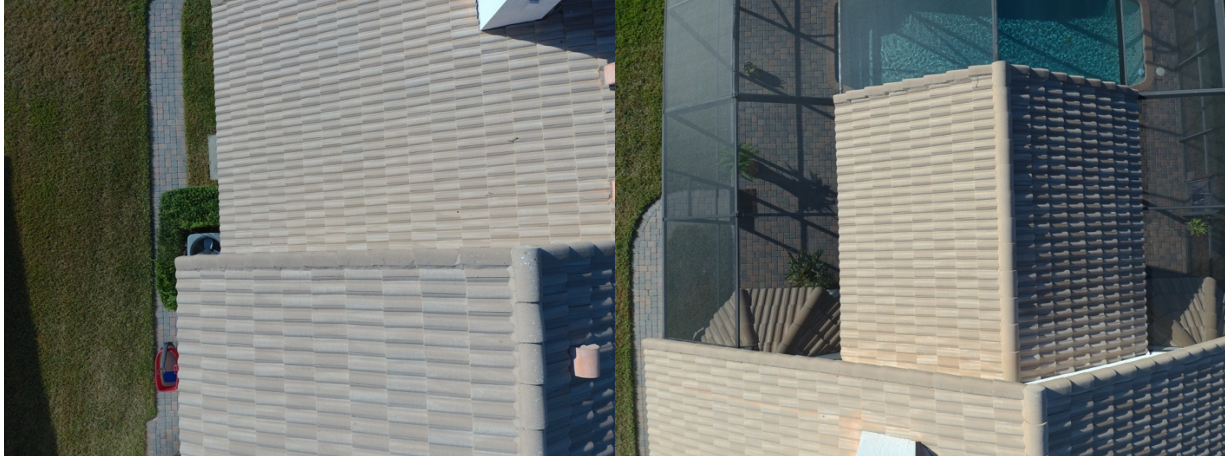
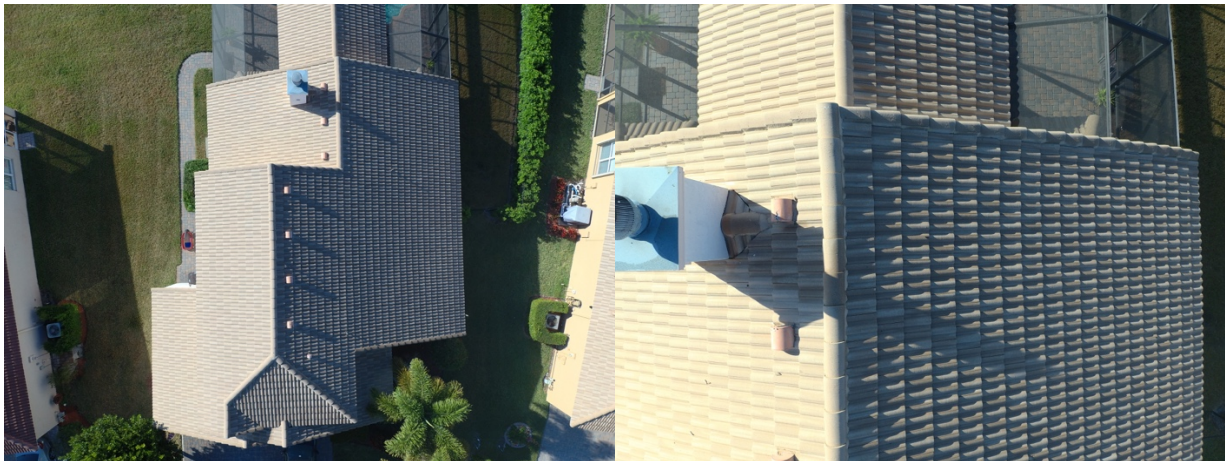
THE ROOF IS SLOPED WITH AN "S" TILE OVER MEMBRANE ROOF SYSTEM. THE ROOF IS THE ORIGINAL, APPROXIMATELY 17 YEARS OLD. THE ROOF IS IN SATISFACTORY CONDITION AND CURRENTLY LEAK FREE. THE NORMAL MAXIMUM ROOF LIFE, FOR THIS TYPE OF ROOF SYSTEMS 25 YEARS.

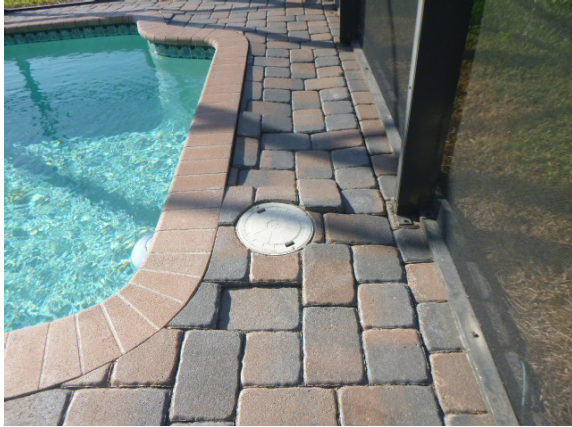
1. THE PAVERS AROUND THE SKIMMER ARE SAGGING IN SEVERAL AREAS. THERE IS A POSSIBILITY OF A SKIMMER LEAK, HOWEVER THERE IS NO OTHER EVIDENCE INDICATING THIS. APPROXIMATE PAVER REPAIR COST. \$200 – \$350

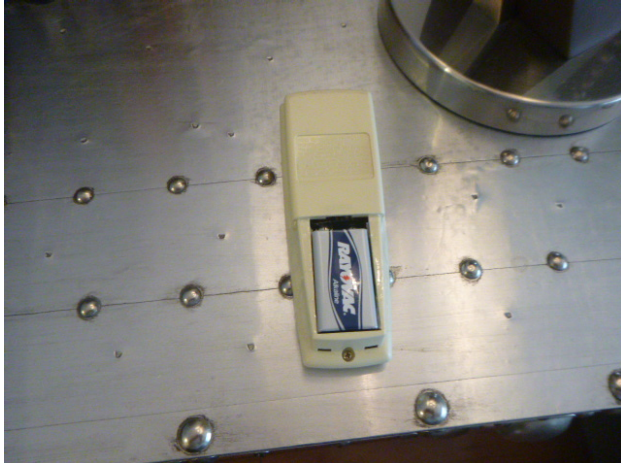
CEILING FANS: WORKING (note, the remote control for the master bedroom ceiling fan is missing the battery cover. Approximate replacement cost. \$10 – \$20

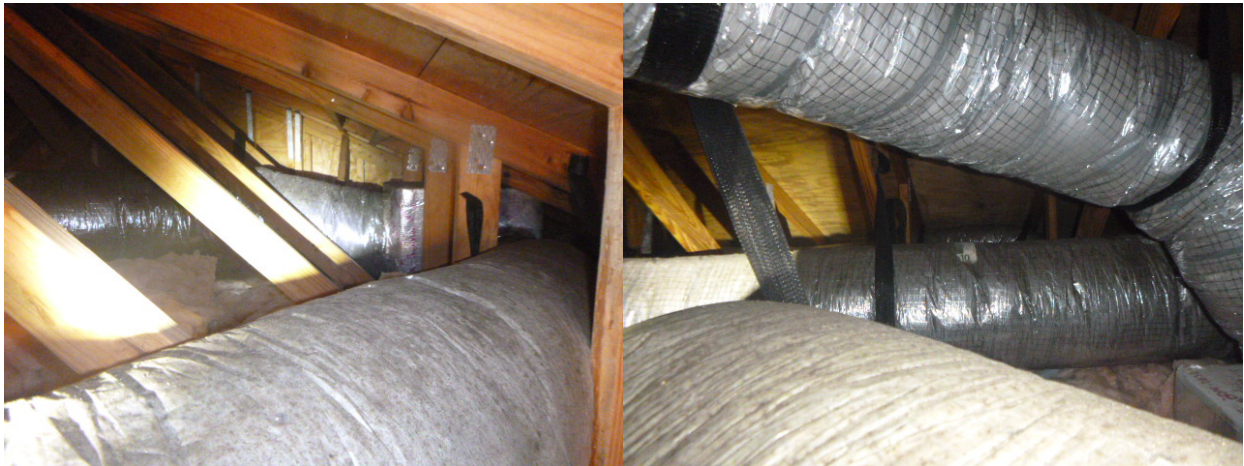
MOLD: SLIGHT SURFACE MOLD EVIDENCE WAS NOTED ON SOME OF THE AIR CONDITIONING DUCT IN THE ATTIC. THIS CAN NORMALLY BE CLEANED WITH STANDARD HOUSEHOLD PRODUCTS AS THE DUCT ITSELF IS A NONPOROUS MATERIAL. APPROXIMATE REMEDIATION COST. \$200 – \$300

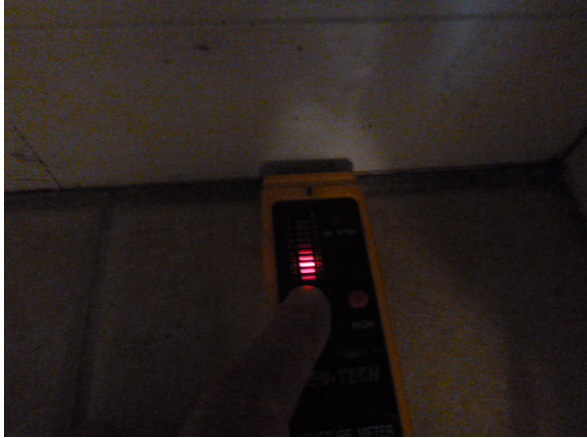
1. THE CLOSET DIRECTLY NEXT TO THE MASTER BATH TOILET WHICH IS LEAKING CHECKED WET INSIDE WITH A MOISTURE METER. MOST LIKELY WHEN THE TOILET WAX RING IS REPAIRED, THIS AREA WILL DRY OUT.
