FELDI'S BUILDING INSPECTIONS

SERVING SOUTH FLORIDA SINCE 1989
INSPECTION REPORT

4321 SAMPLE REPORT
TOWNHOUSE
FORT LAUDERDALE

INSPECTION DATE: 1-21 -2021

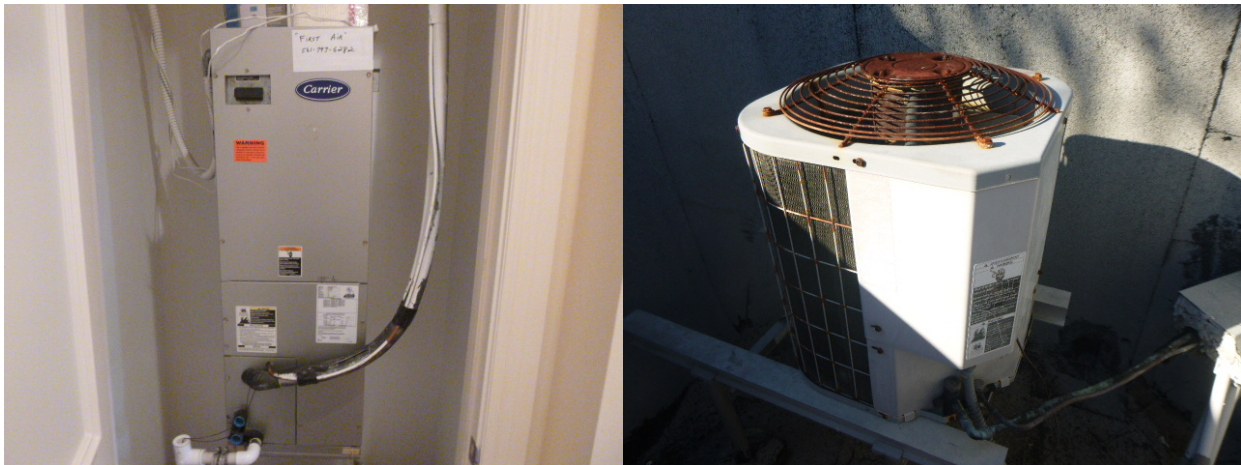
SERVICING OR REPLACEMENT NECESSARY: THE FIRST FLOOR AIR-CONDITIONING HAD ONLY A 6 DEGREE TEMPERATURE DIFFERENTIAL. A 71 DEGREE READING WAS TAKEN AT THE RETURN AIR GRILL AND A 65 DEGREE READING AT THE DIFFUSER. THE AIR CONDITIONING CONTRACTOR SHOULD CHECK FOR A PROBABLE REFRIGERANT LEAK. HOWEVER, DUE TO THE AGE OF THIS AIR-CONDITIONING SYSTEM, REPLACEMENT MAY BE RECOMMENDED. APPROXIMATE REPAIR OR REPLACEMENT COST. \$1500 – \$4500 (note, the air conditioning system was manufactured in 2002 the normal maximum life air conditioning system, is 13 to 15 years. The photo below left is the inside air handler, located in a hall closet near the garage. The photo below right is the exterior condensing unit, located on the roof.)

On air-conditioning systems over five years old, it is common for coils to need cleaning in the air handler. Also, there is a possibility of concealed mold evidence inside the air handler cabinet, due to the age of this unit. Our air conditioning inspection is noninvasive, consequently we do not open up the air conditioning unit and inspect the insides. **A licensed air-conditioning contractor should be acquired prior to purchase of the property,** for an internal assessment of the condition of the air handler. As well as inspecting for concealed mold inside the air handler and adjacent ductwork.

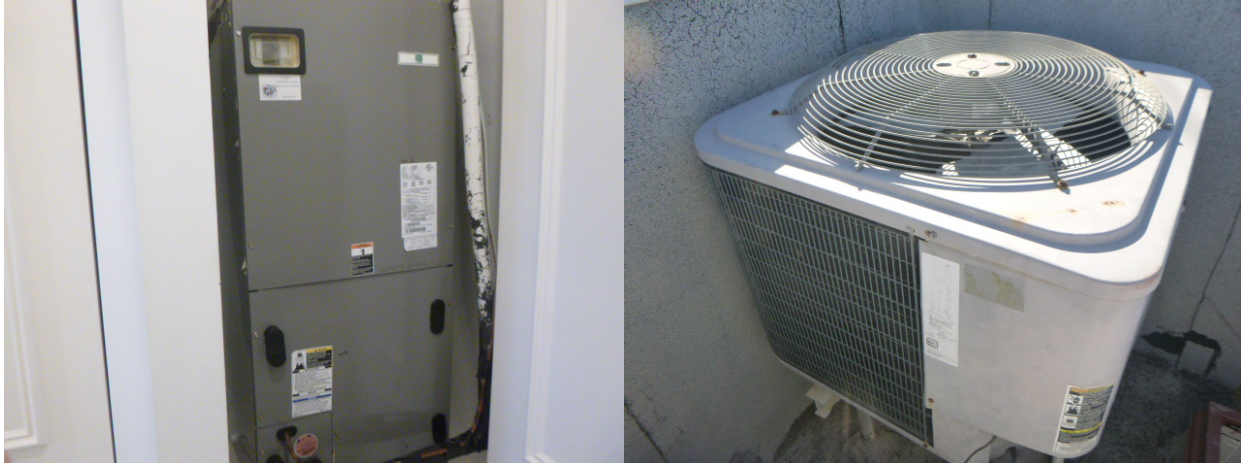
THE SECOND FLOOR AIR-CONDITIONING WAS WORKING PROPERLY WITH A 19 DEGREE TEMPERATURE DIFFERENTIAL. A 69 DEGREE READING WAS TAKEN AT THE RETURN AIR GRILL AND A 50 DEGREE READING AT THE DIFFUSER. (note, the inside air handler located in a second-floor closet was manufactured in 2019. The exterior condenser unit located on the roof, was manufactured in 2002. The normal maximum life for an air conditioning unit, is 13 to 15 years. Soon replacement of the rooftop condensing unit may be necessary. The photo below left is the inside air handler in the photo below right is the exterior condensing unit.)

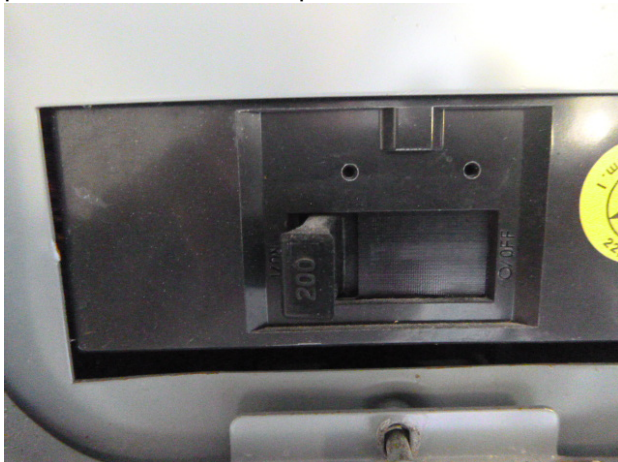
SERVICE AMPERAGE SIZE: 200 amps— the main electrical disconnect is located inside the garage electrical panel at the bottom, see photo below.

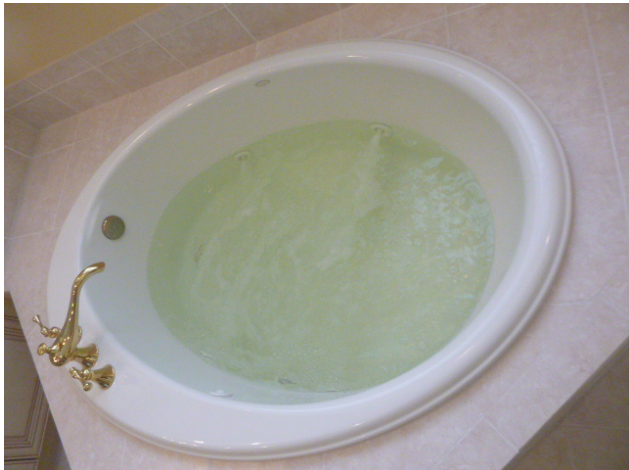
(Note, the Jacuzzi motor is sealed in behind the bathtub enclosure and consequently could not be inspected. This was a previously acceptable installation. However, current requirement provides for an access panel making the motor and electrical items accessible for inspection or repair.)

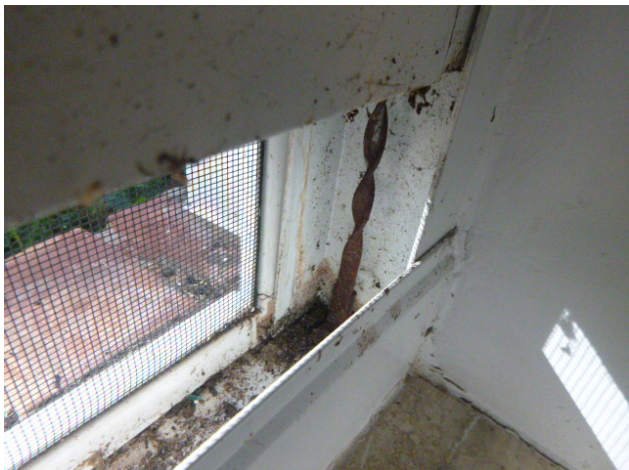
1. FOYER WINDOW HAS A BROKEN WINDOW SPRING. APPROXIMATE REPAIR COST. \$45 – \$95

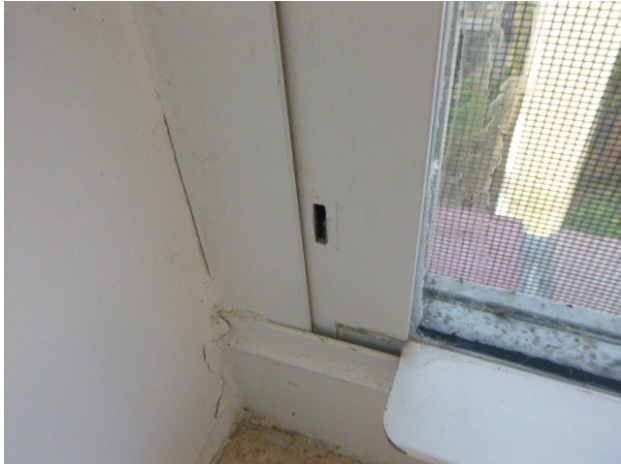
2. MASTER BEDROOM, WEST WINDOW IS MISSING THE WINDOW GUIDES AT THE BOTTOM. APPROXIMATE REPLACEMENT COST. \$25 – \$35

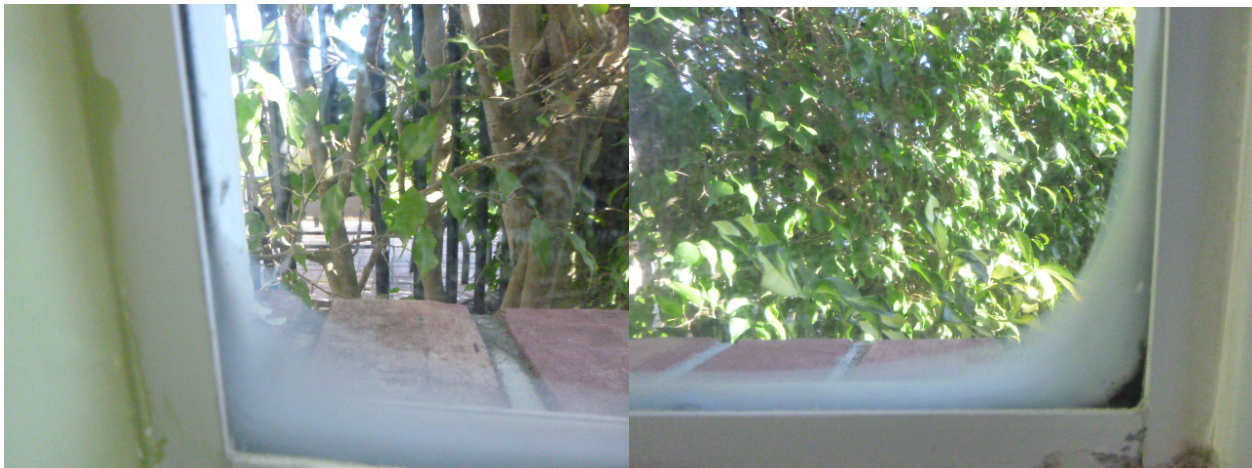
NOTE: THE NORTH KITCHEN BAY WINDOW HAS BREACHED LEAVING A CLOUDED EDGE AT THE BOTTOM. THIS IS AN IMPACT WINDOW AND WILL NOT AFFECT THE PROTECTION OF THE WINDOW. THIS IS A COSMETIC BLEMISH; HOWEVER, IT IS POSSIBLE IT COULD WORSEN.

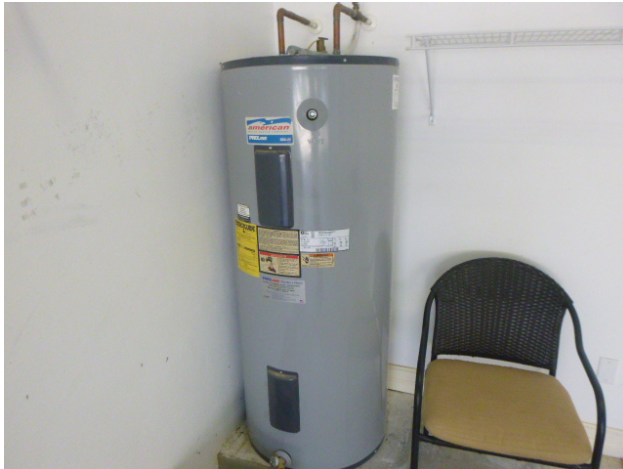
HOT WATER HEATER: ELECTRIC DOUBLE ELEMENT TYPE: WORKING (note, the water heater was manufactured in 2001 and has a 80 gallon capacity. The normal maximum life water heater, is 13 to 15 years. The photo below is the water heater, located in the garage.)

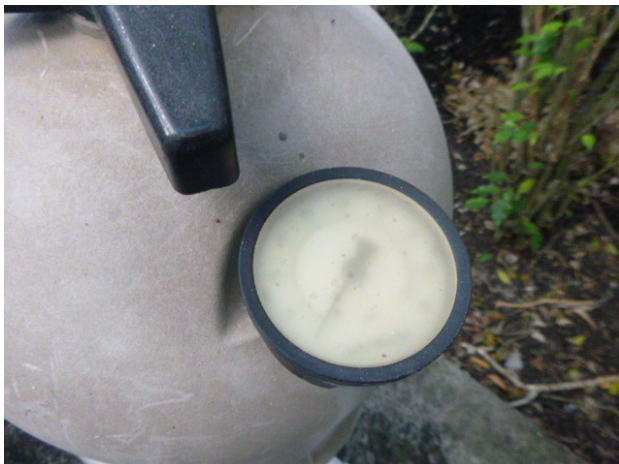
1. THE FILTER PRESSURE GAUGE IS DAMAGED. APPROXIMATE REPLACEMENT COST. \$75 – \$125

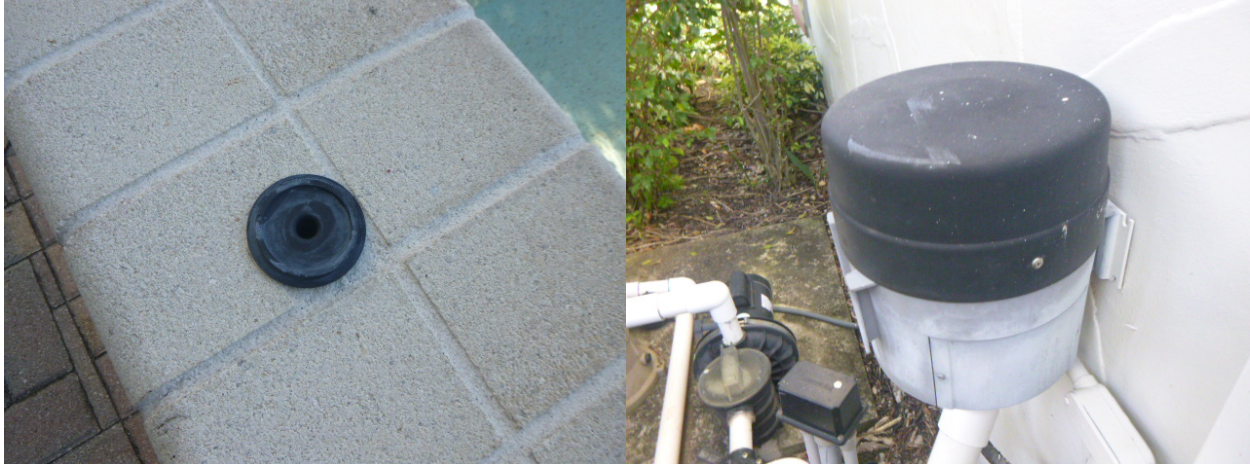
2. THE SPA AIR BLOWER COULD NOT BE TESTED, AS THE AIR SWITCH IS DEFECTIVE. APPROXIMATE SWITCH REPAIR COST. \$100 – \$200 (approximate air blower replacement cost if necessary. \$200 – \$400

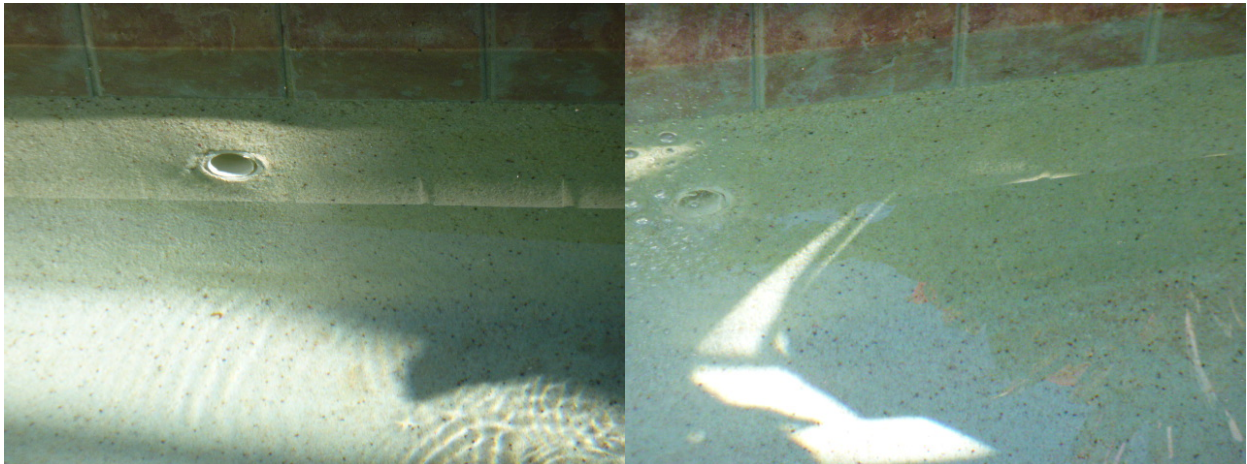
3. ALL OF THE NOZZLES INSIDE THE JACUZZI TUB ARE BROKEN. APPROXIMATE REPAIR COST. \$45 – \$75 EACH

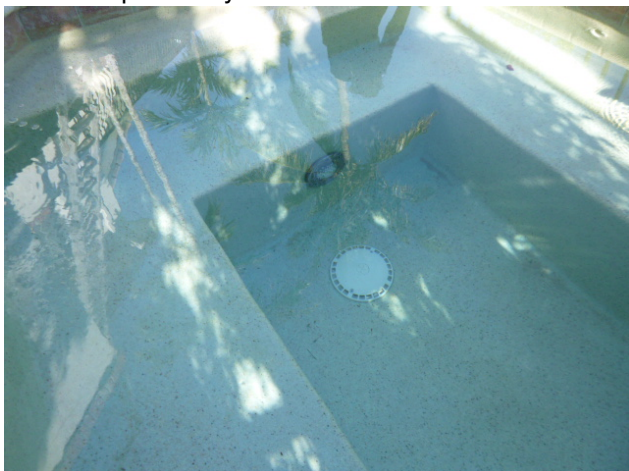
4. SPA LIGHT DOES NOT APPEAR TO BE WORKING. APPROXIMATE REPAIR CAUSE. \$75 – \$175 (note, there is a possibility the correct switch was not located for the light.)

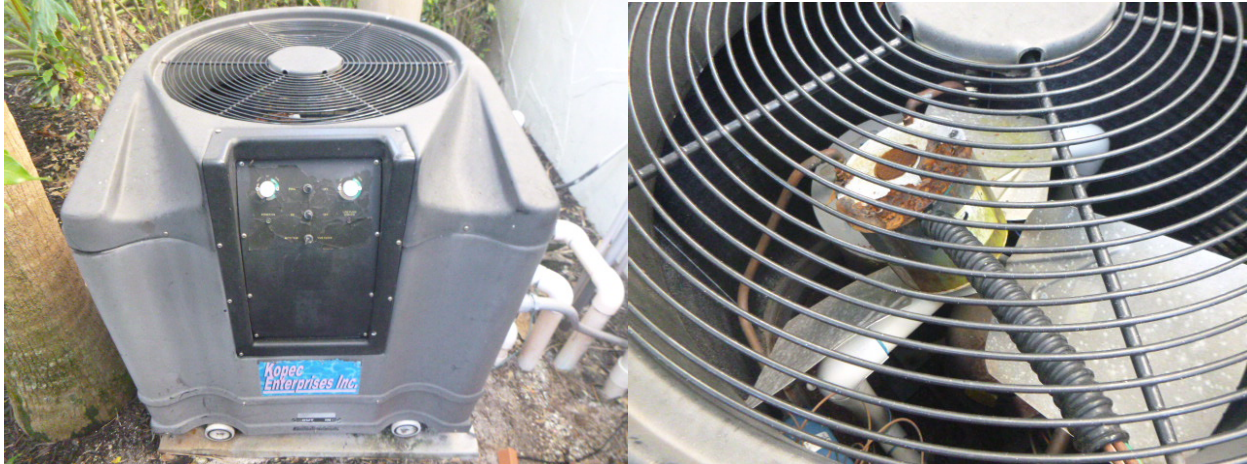
SPA HEATER: ELECTRIC HEAT PUMP TYPE, NOT WORKING AND APPEARS TO BE OLD AND DAMAGED. APPROXIMATE REPLACEMENT COST. \$3500 – \$4500
