FELDI'S BUILDING INSPECTIONS

INSPECTION REPORT

1224 SAMPLE REPORT
HOUSE
DELRAY BEACH FL

INSPECTION DATE: 1-26 -2021

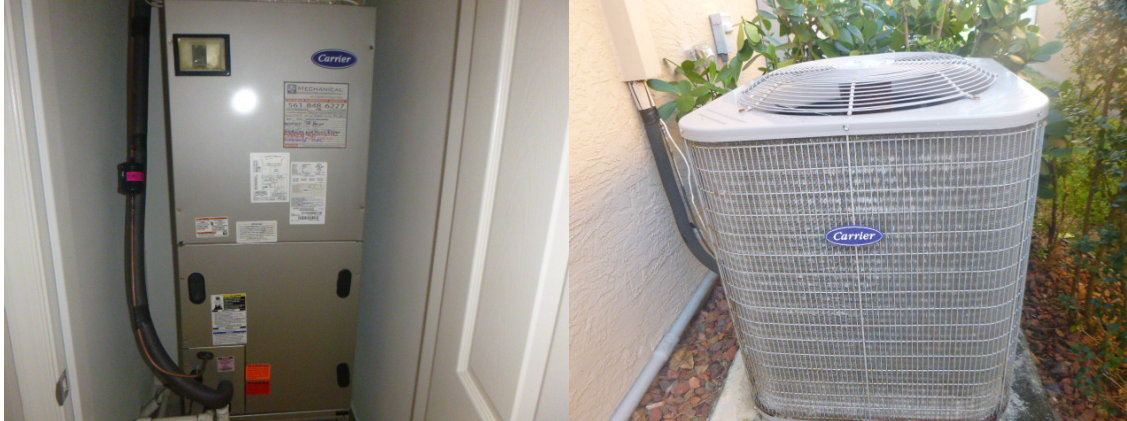
AIR-CONDITIONING: NOT COOLING PROPERLY, SERVICING NECESSARY

THE AIR-CONDITIONING HAD ONLY A 13 DEGREE TEMPERATURE DIFFERENTIAL. A 73 DEGREE READING WAS TAKEN AT THE RETURN AIR GRILL AND A 60 DEGREE READING AT THE DIFFUSER. THE REPAIRING CONTRACTOR SHOULD CHECK FOR A POSSIBLE REFRIGERANT LEAK. APPROXIMATE REPAIR COST. \$250 – \$1900 (note, the air conditioning system was manufactured in 2015 the normal maximum life air conditioning system, is 13 to 15 years. The photo below left is the inside air handler, located in a closet near the laundry room. The photo below right is the exterior condensing unit.)

On air-conditioning systems over five years old, it is common for coils to need cleaning in the air handler. Also, there is a possibility of concealed mold evidence inside the air handler cabinet, due to the age of this unit. Our air conditioning inspection is noninvasive, consequently we do not open up the air conditioning unit and inspect the insides. **A licensed air-conditioning contractor should be acquired prior to purchase of the property,** for an internal assessment of the condition of the air handler. As well as inspecting for concealed mold inside the air handler and adjacent ductwork.

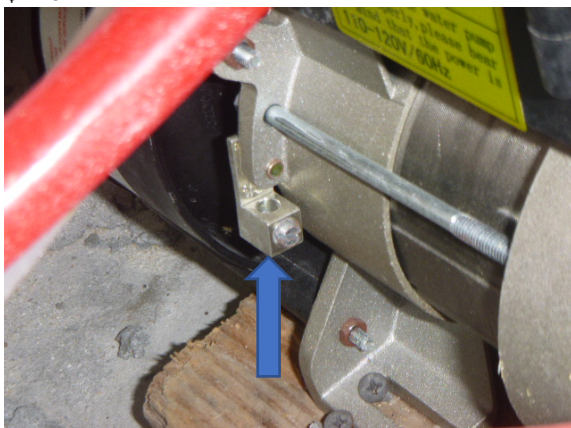
1. FRONT EXTERIOR ENTRY; THE GFCI PLASTIC OUTLET COVER DOOR FALLS OFF. APPROXIMATE REPAIR COST. \$35 – \$55
2. SOUTH EXTERIOR ATRIUM WALL LIGHT IS NOT WORKING. APPROXIMATE REPAIR COSTS. \$5 – \$15
3. JACUZZI MOTOR EXTERNAL GROUND WIRE IS MISSING. APPROXIMATE REPLACEMENT COST. \$75 – \$125

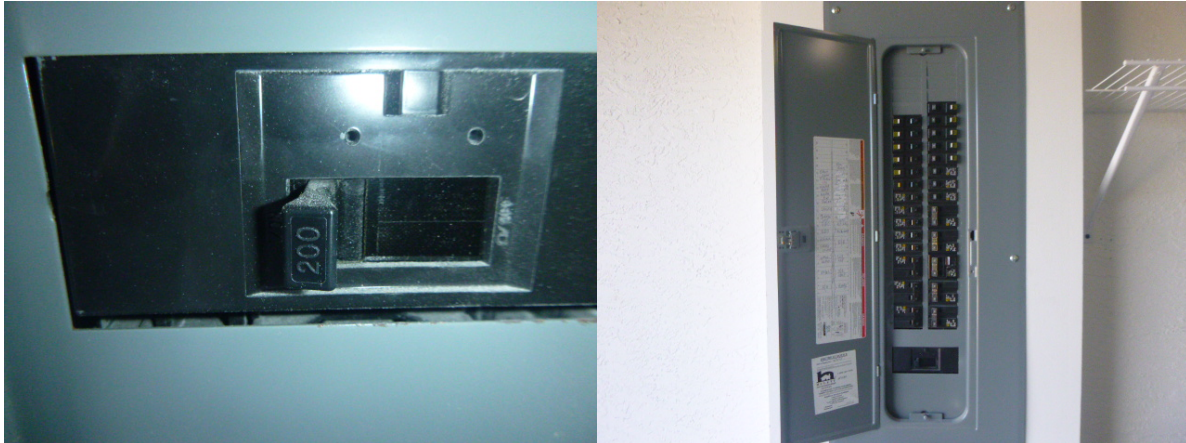
SERVICE AMPERAGE SIZE: 200 amps— they main electrical disconnect is located inside the garage electrical panel at the bottom, see photos below.

(Note: the electrical panel was manufactured by Square D)

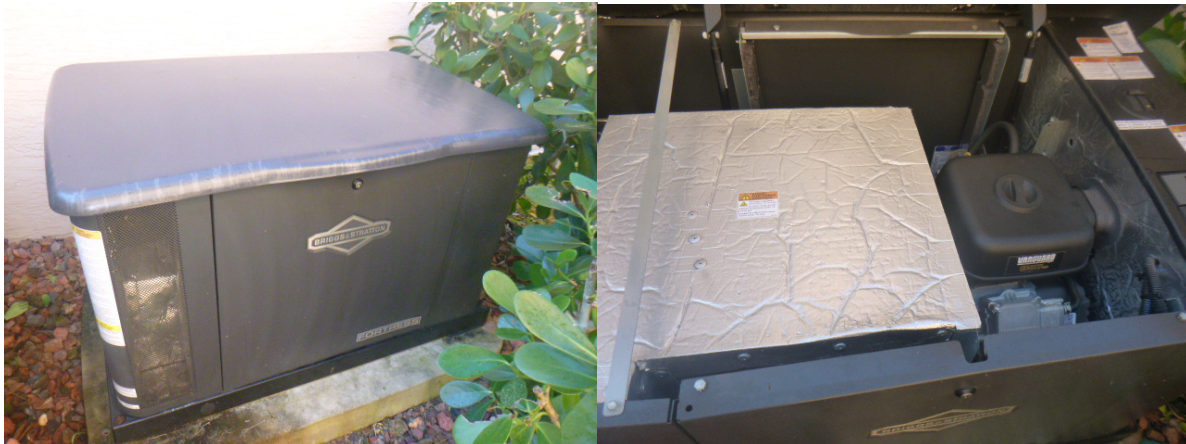
GENERATOR: THE GENERATOR AND SWITCHGEAR ALL APPEARS TO BE OPERATING PROPERLY. SEE SELLER TO DETERMINE IF THE GENERATOR WAS DESIGNED TO TO OPERATE THE ENTIRE HOME OR ONLY A PORTION.

(Note: the generator inspection is a partial inspection, it determines if the motor is operating properly. This inspection does not include any of the related components or switchgear. A licensed electrical contractor would need to be acquired, for a complete comprehensive evaluation of the generator and related components.)

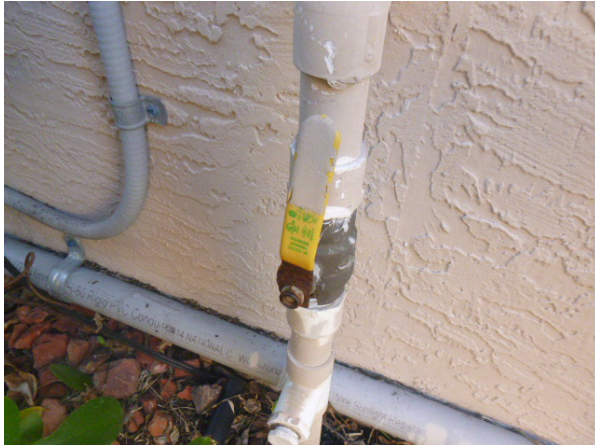
WATER MAIN SHUT OFF LOCATION: NORTH EXTERIOR, SEE PHOTO BELOW

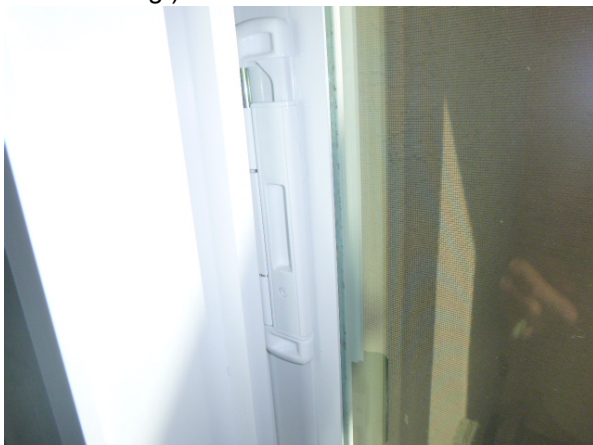
1. FRONT NORTH BEDROOM HALLWAY AREA BIFOLD CLOSET DOOR OPERATES HARD. APPROXIMATE REPAIR COST. \$45 – \$65
2. FRONT SOUTH BEDROOM SLIDING GLASS DOOR AND SLIDING SCREEN DOOR COULD NOT BE TESTED. THERE IS AN ADDED LOCK BY THE HOMEOWNER THAT DID NOT UNLOCK AT THE BOTTOM PORTION. APPROXIMATE DOOR REPAIR COST IF NECESSARY. \$45 – \$95 EACH (the bottom portion of the lock in the photo was stuck. This lock was added by the homeowner. The original sliding glass door lock appears to be working.)

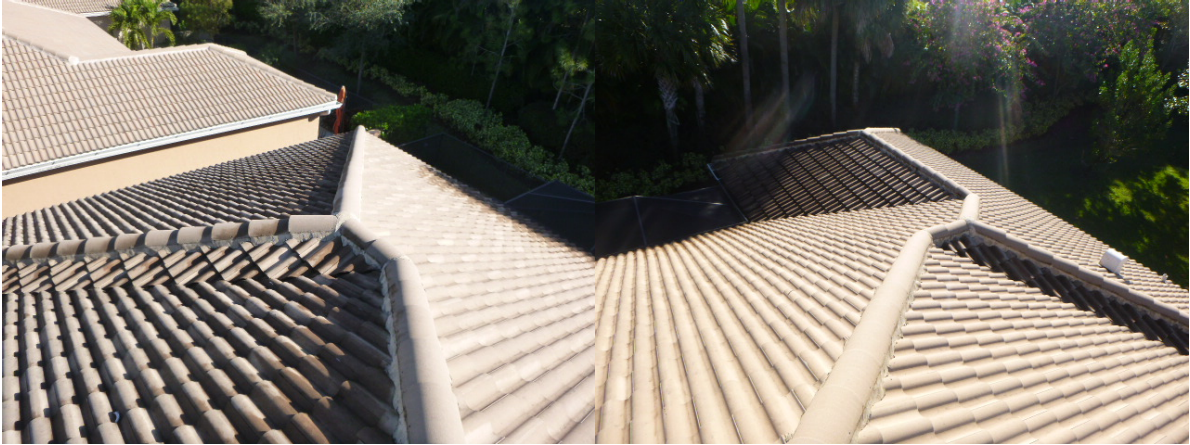
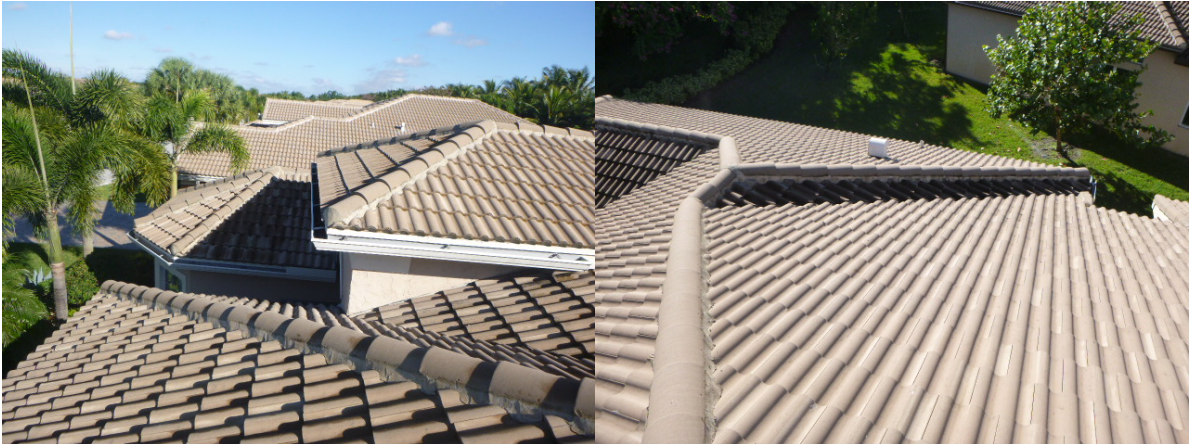
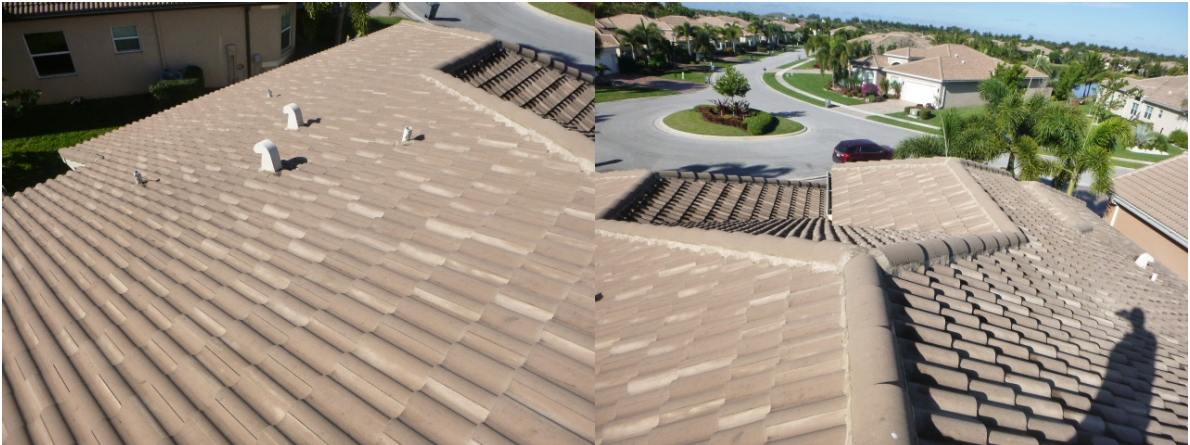
ROOF: THE ROOF IS SLOPED WITH AN "S" TILE OVER MEMBRANE ROOF SYSTEM. THE ROOF IS THE ORIGINAL, APPROXIMATELY FIVE YEARS OLD. THE ROOF IS IN SATISFACTORY CONDITION AND CURRENTLY LEAK FREE. THE NORMAL MAXIMUM ROOF LIFE, FOR THIS TYPE OF ROOF SYSTEM IS 25 YEARS. ALSO, THERE WERE TWO OR THREE CRACKED ROOF TILES. THESE TILES CAN BE REPAIRED WITH THE APPROPRIATE ROOF ADHESIVE SUCH AS RT 600 OR POLY FOAM. THIS REPAIR CAN BE MADE BY HANDYMAN. APPROXIMATE REPAIR COST. \$100 – \$150 (note, the realtor stated this roof is going to be pressure washed in the very near future by the Association. There is a possibility when they are walking on the roof that additional tiles could crack.)

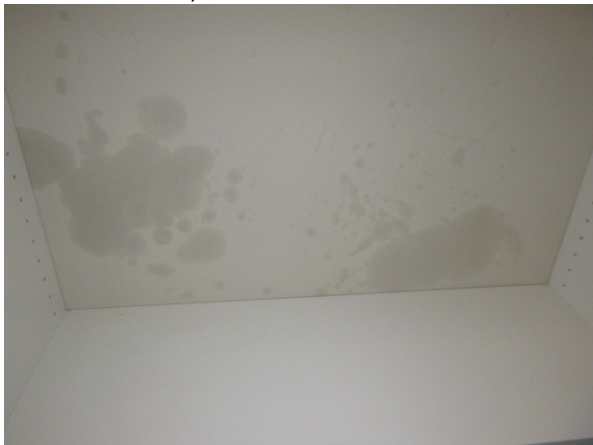
WATER INTRUSION: NO VISIBLE EVIDENCE FOUND (note, the front north bedroom closet wall has some type of staining. It appears to be from something being stored in the closet. The wall checks dry with a moisture meter.)
