# FELDI'S BUILDING INSPECTIONS

SERVING SOUTH FLORIDA SINCE 1989  
INSPECTION REPORT

123 SAMPLE REPORT  
CONDO #207  
BOCA RATON FL

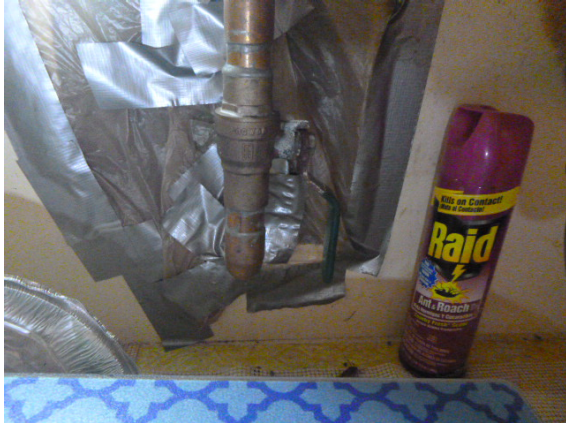
**WATER MAIN SHUT OFF LOCATION:** UNDER THE KITCHEN SINK AREA, SEE PHOTO BELOW

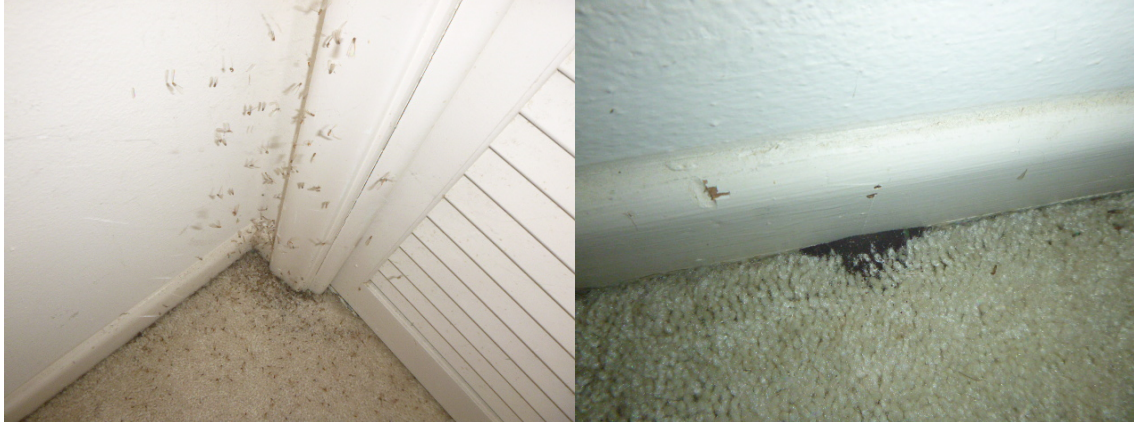
ALSO, THE ASSOCIATION SHOULD BE NOTIFIED AS THERE WAS EVIDENCE OF TERMITES AND THE CONDO. A LICENSED TERMITE INSPECTOR SHOULD BE ACQUIRED FOR FURTHER EVALUATION AND TREATMENT.
